The Construction and Structure Reliability of *Jam Gadang*: The Heritage of West Sumatra

Abstract

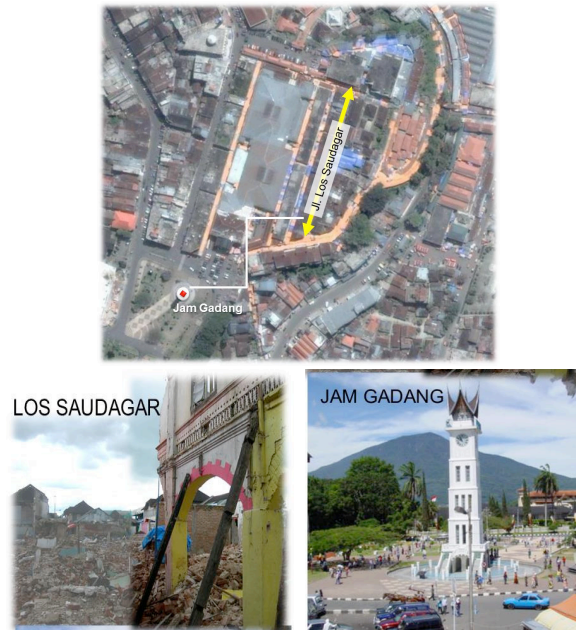
different impact on building of *Jam Gadang* and *Los Saudagar*. In other words, the earthquake collapsed the building of *Los Saudagar* and gave a little crack for *Jam Gadang*.

Figure 1 Position of *Jam Gadang* dan Los Sudagar in Post Earthquake 2007

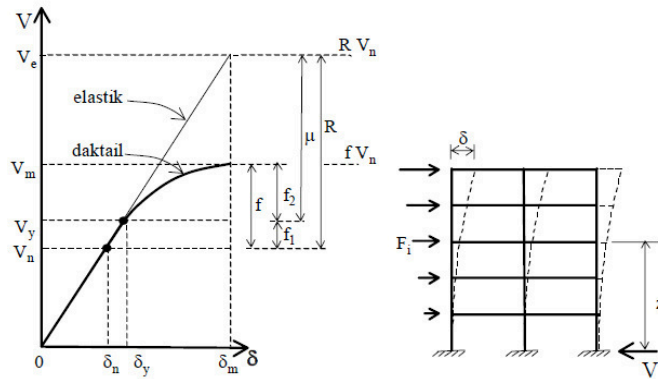
Results of analysis on the structural reliability of *Jam Gadang* will be confirmed on the theory of the full elastic structure (see Fig 3), the condition of the structure is on the verge of collapse is achieved in line with the first thaw in the structure ($\delta m = \delta y$)

Figure 3 Load-Displacement Structure Building Diagram

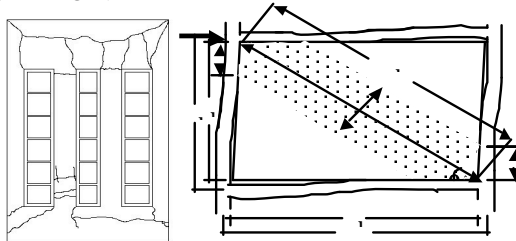
The dominant damage in the masonry wall, this model is most common in the wall panel charger which direction diagonal joint-burdened will experience the press, otherwise the diagonal direction perpendicular to experience the attraction, the tension force caused a diagonal panel crack (see Fig 5).

Figure 5 Strut Diagonal Crack of Masonry

The efforts of construction data recording and structure of *Jam Gadang* have produced the current condition, whereas no damage found. In other words, the *Jam Gadang* is generally in safety. Although, the wall of *Jam Gadang* only suffered damage on plaster, and there are no new cracks as consequences of earthquake in March 2007 and September 30th, 2009. The foundation with depth of 1690 mm arranged are found no damage. Furthermore, there is no signs of damage found on the ground floor. Therefore the column must consist of reinforced concrete structure that still has sufficient capacity. The analysis of structural reliability displays that the *Jam Gadang* is elastic on seismic load with a maximum deviation which accounted for 63.00 mm. This finding is relatively compared to 3D application laser scanner

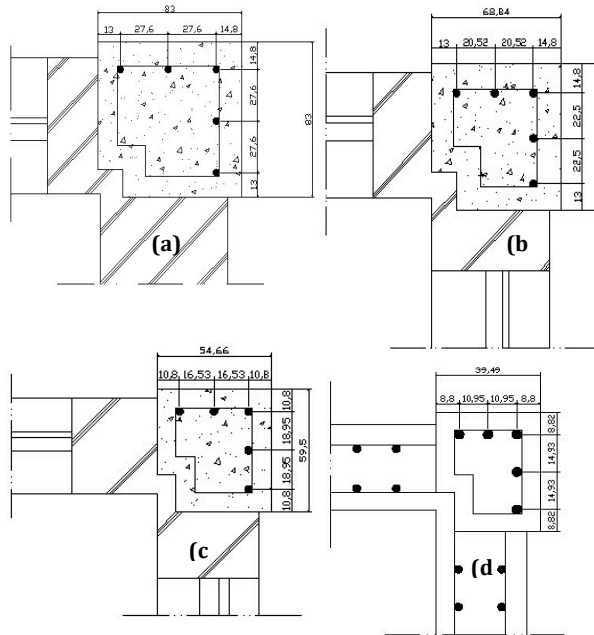
The column is a reinforced concrete structure with varied dimensions (see Fig 7) *Jam Gadang* has four reinforced concrete columns on each floor which is located on the four corners of the building that its vertical geometry growing smaller to the top, but the columns is aligned. The damage that occurs only in the form cracked cover width 0.5-0.8 mm at outer side in the column direction on first floor only.

Figure 7 Results of Identification on Column (a) 2nd Story (b) 3rd Story (c) 4th Story (d) 5th Story

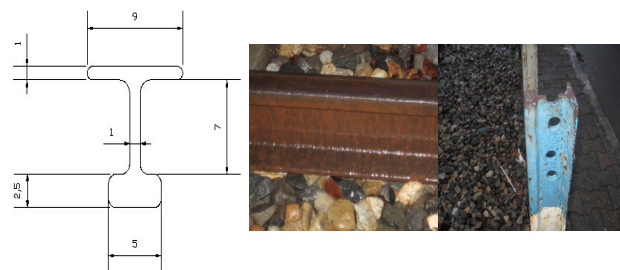
The beams and floor slabs on the building of the *Jam Gadang* has a composite structure. Based on the results of examination found no new damage to the floor plate and beams, while the dimentions of the slab is as follows (see Table 1).

Figure 8 H-Beam of Composite Beams and Slab

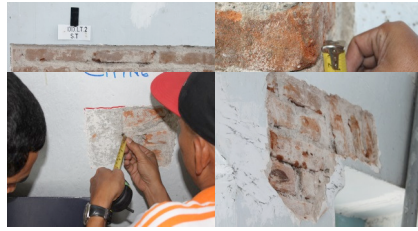
The walls of the *Jam Gadang* is built from a masonry (see Fig 9) with varying thickness, respectively 640 mm, 600 mm, 460 mm and 340 mm. Dimensions of brick is an average size of 180x130x50 mm.

Figure 9 Masonry Wall

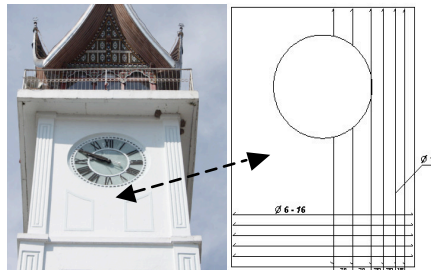
The walls of *Jam Gadang* are not designed as a structure, wall as a partition. It is not found anchorage to the walls of the columns, but a special wall at 5th story is true planned as part of the construction to bear clock (see Fig 10)

Figure 10 Reinforcement Configuration in Top Wall

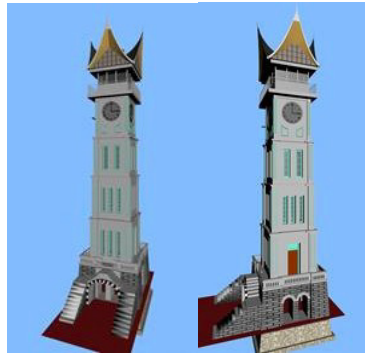
Based on the results of construction data recording, it is found the construction modeling (see Fig 11) and structural modeling of Jam Gadang (see Fig 12).

Figure 11 Construction Modelling

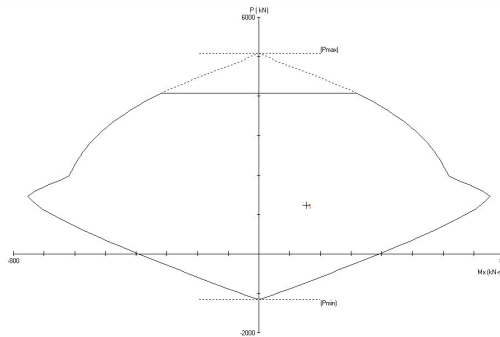
The capacity of column provided is still meet the requirement of strength and stiffness, availability of reinforcement extents (minimum reinforcement ratio) on the seismic load plan. This findings can be seen from charts of column interaction (see Fig 13)

Figure 13 P-M Interaction Diagram 1st Column

Therefore, in the early stages of rehabilitation plan of Jam Gadang, it is not necessary yet to strengthen the structure. However, the efforts to reduce building load besides providing protection on architectural elements in line with time of building, and restriction for the numbers of visiting guests.
